DEPARTMENT OF TRANSPORTATION**DIVISION OF ENGINEERING SERVICES**

Office of Structural Materials

Quality Assurance and Source Inspection

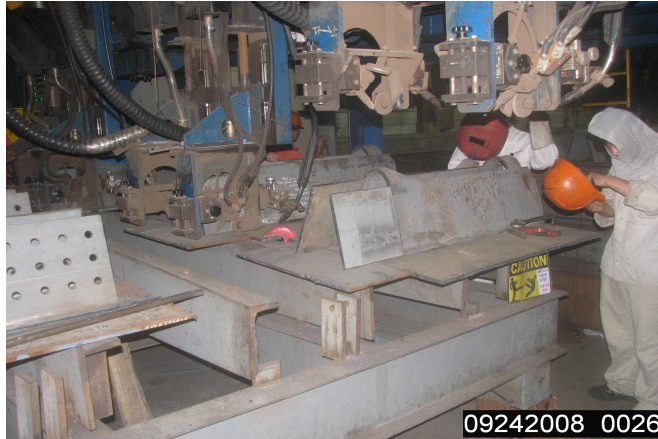
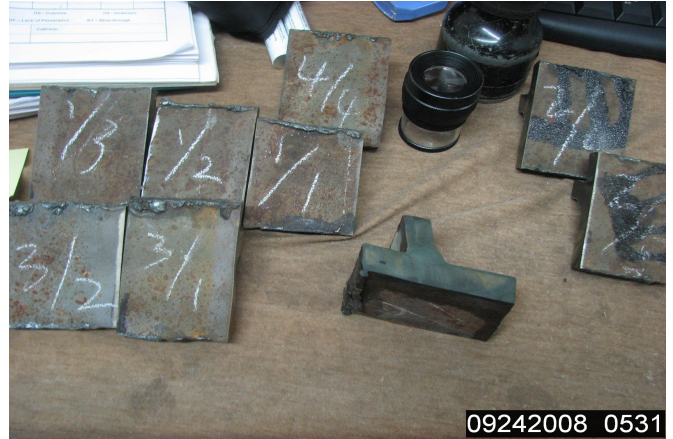
accepted by ZPMC, ABF and Caltrans. See Caltrans U-ribs PMT Inspection Sheet, dated 09-24-08 and ZPMC production monitoring test plate inspection report, dated 09-24-2008 for additional information. The following picture illustrates welding of the PMT and typical macroetch specimens.
